**South Capel Remediation Project, WA**  
**EPBC 2018/8250**  
**Annual Compliance Report**  
**23 September 2023 – 22 September 2024**

Revision: 0

Date: 24 September, 2024

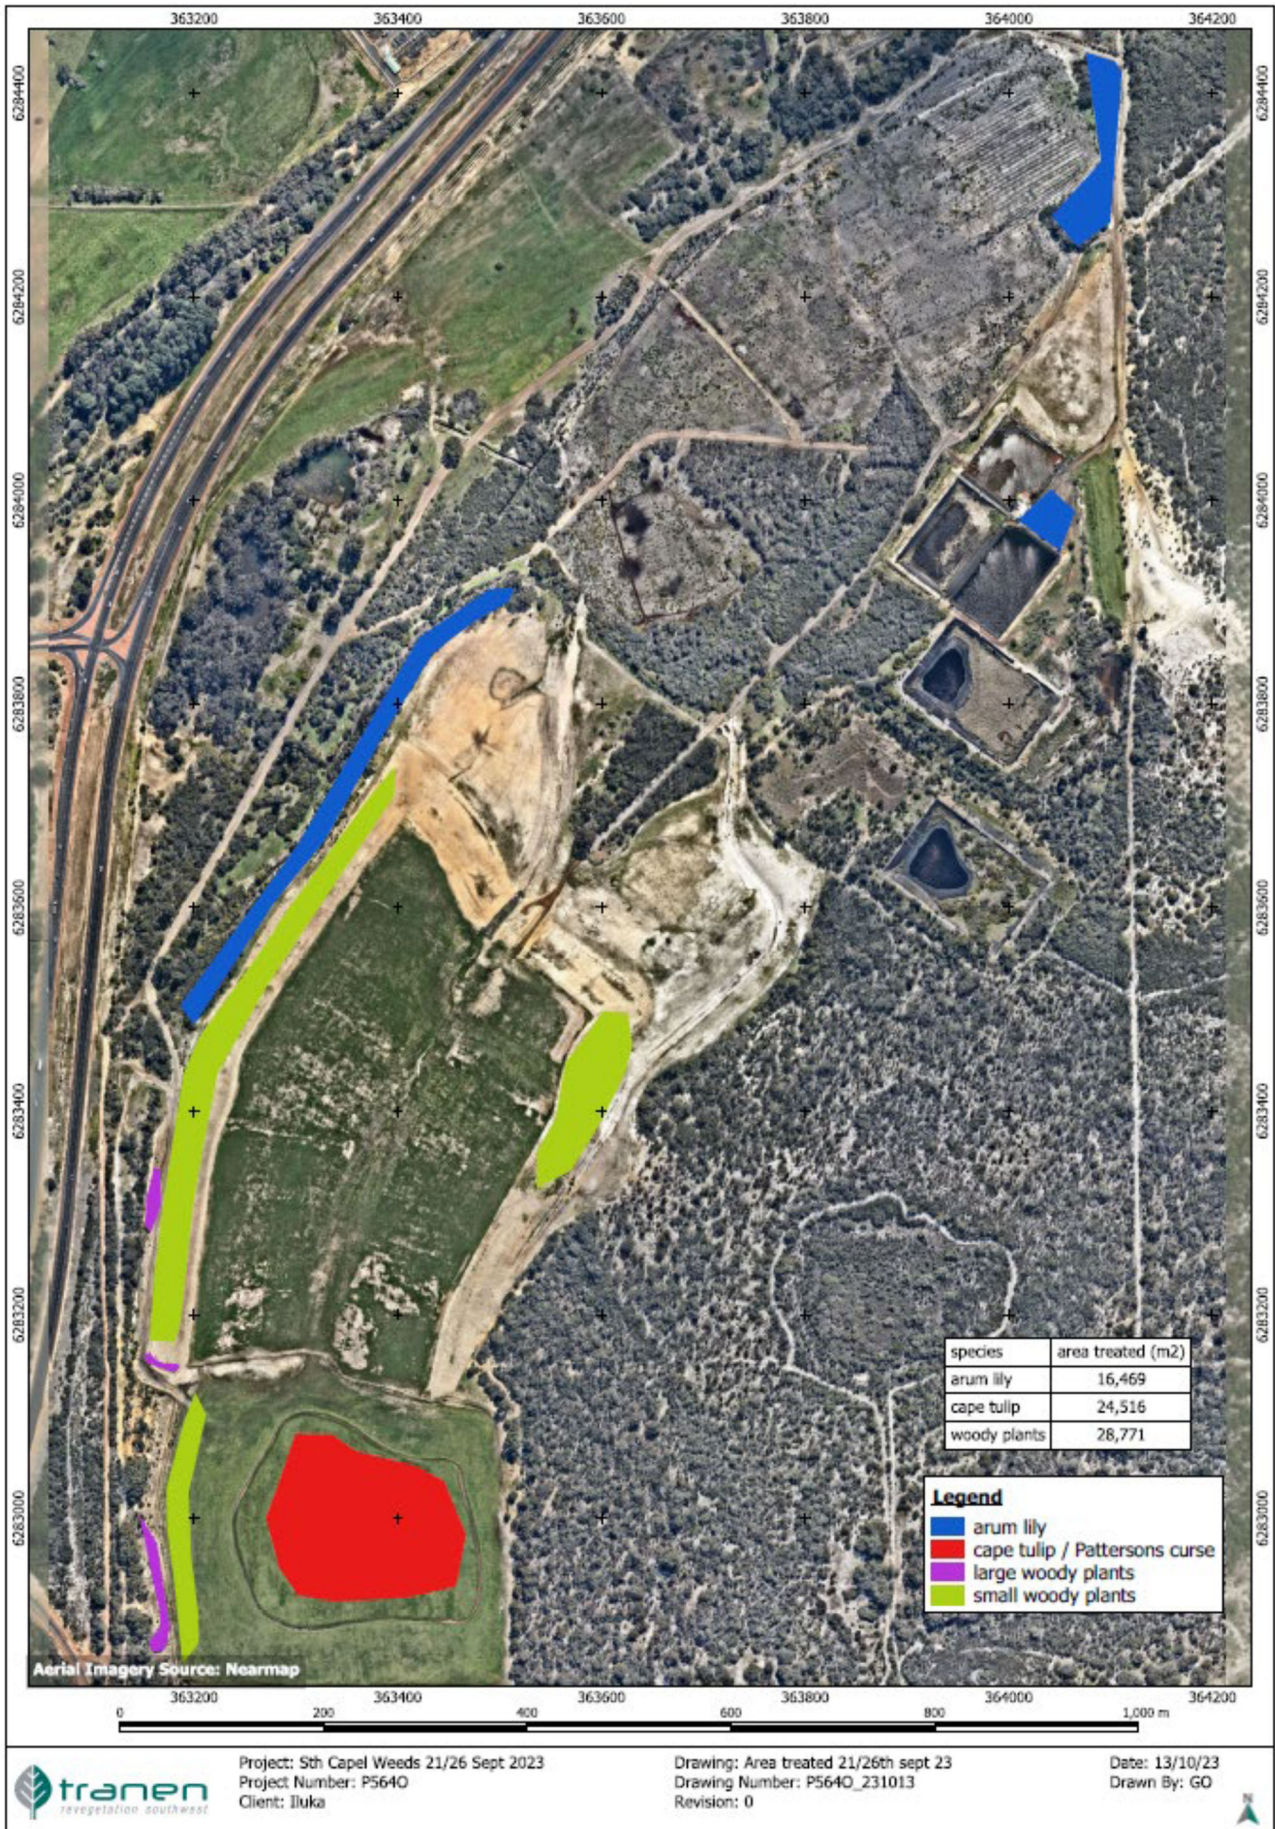
Figure 3 – Weed Control September 2023

Weed control undertaken in 2023 targeted declared and woody weeds outside the WRP habitat area. Arum lily (*Zantedeschia aethiopica*) was found adjacent to the WRP habitat area and was treated via herbicide application. made up of were recorded as part of the Year 1 Monitoring Report (RPS, 2022). Control areas are illustrated within Figure 3.

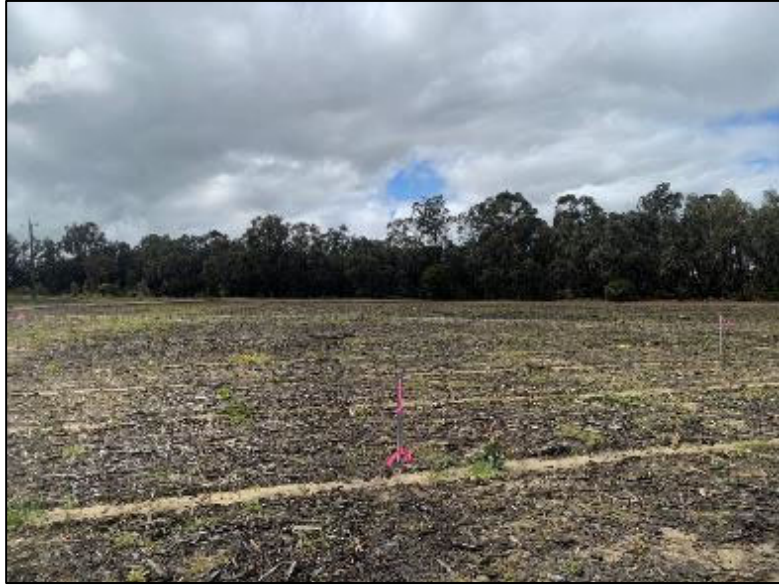
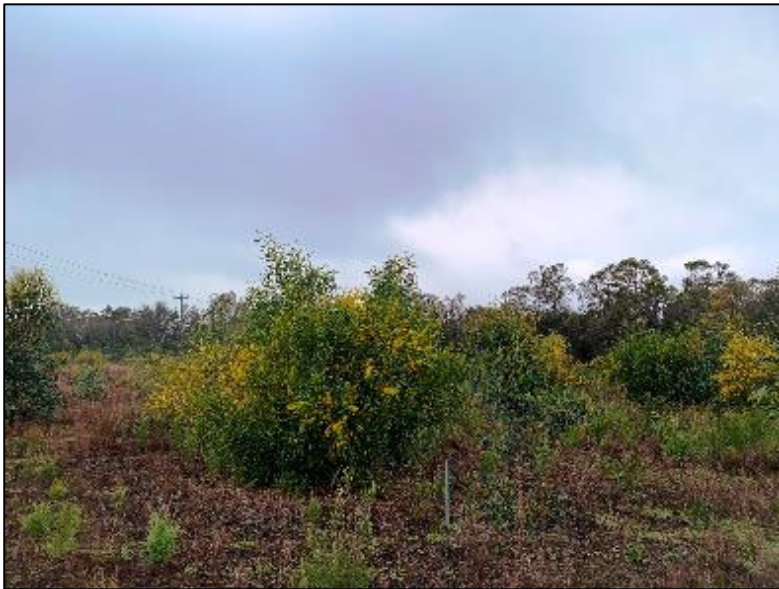
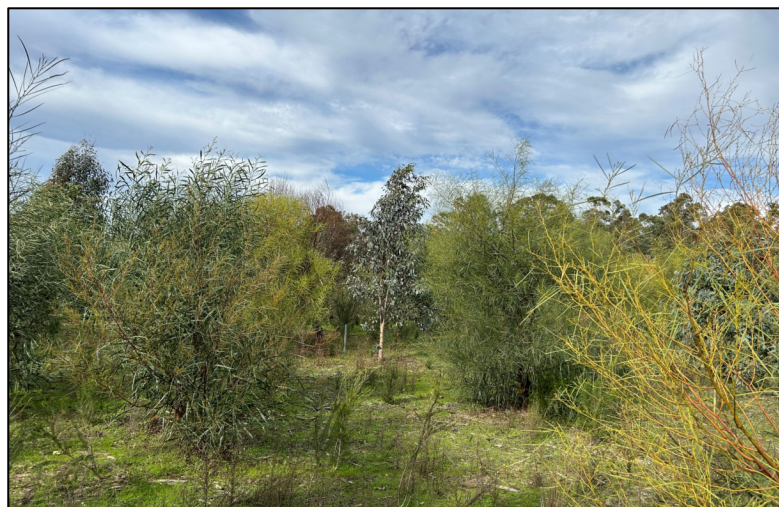
**Plate 1 – WRP Offset Area Monitoring Quadrat**  
**A: October 2021; B: September 2023; C: June 2024**

Plate 1 illustrates the development within one quadrat over a 36 month period. Plate 2 provides a broader view of plant establishment across the site.
