# Sierra Rutile Project Area 1 – Environmental, Social and Health Impact Assessment: Mine Closure Plan

Report Number: 515234/ Mine Closure Plan

March 2018

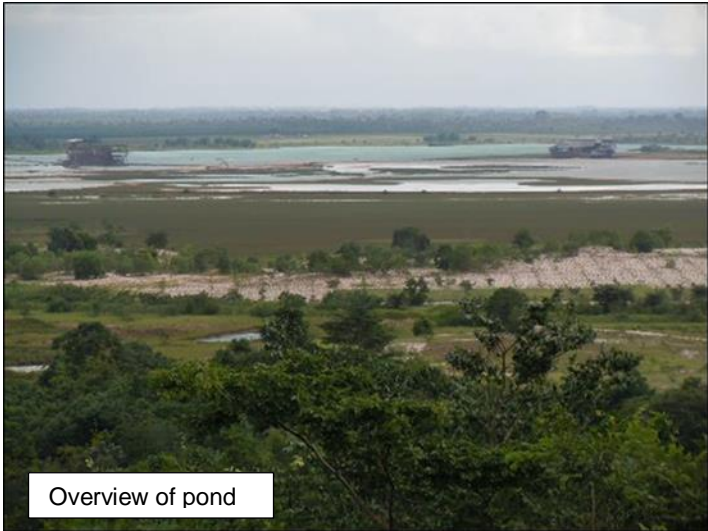
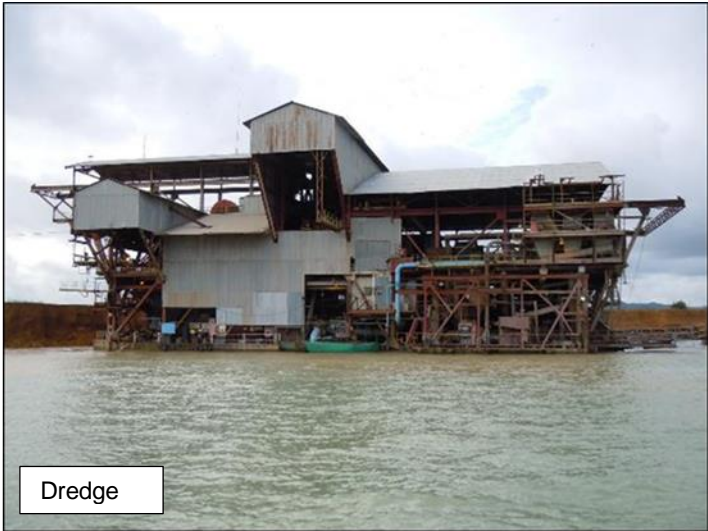
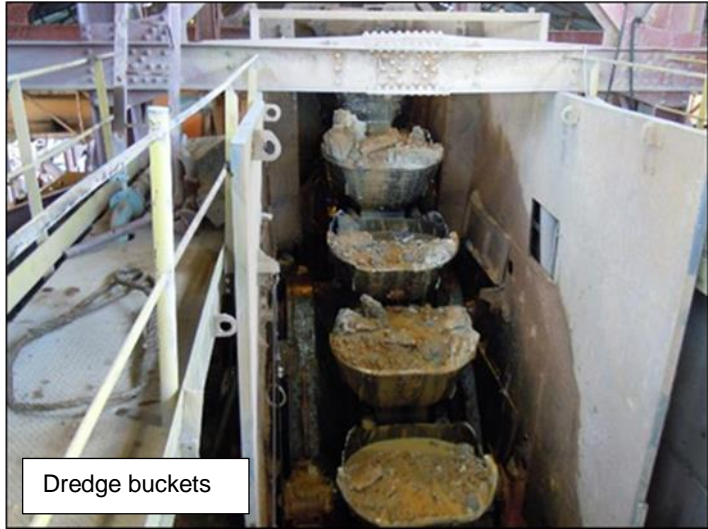
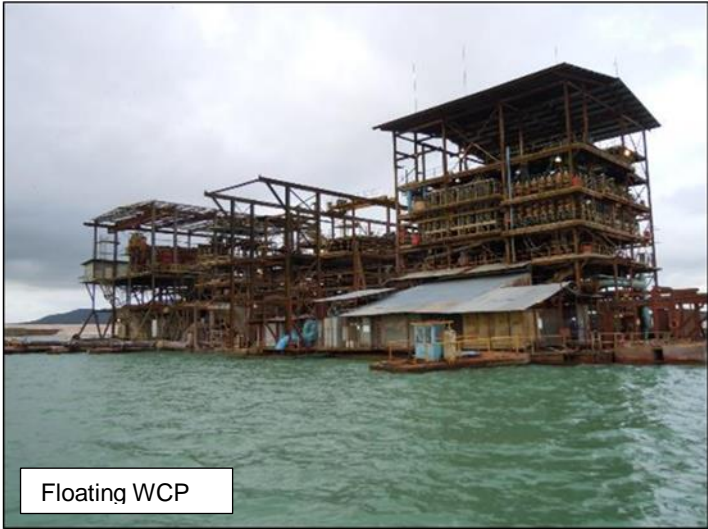
Figure 2-3: Lanti wet mining operations

The dredge scrubs and screens the ore, after which it is pumped to the floating WCP. De-sliming removes clay from the ore. The de-sliming process occurs in two stages. Gravity then separates the heavier minerals from the lighter minerals. The resultant Heavy Mineral Concentrate (HMC) contains up to 60 % recoverable rutile. The concentrate then goes to two separate cyclone towers: one for low sulfur ore and a second one for high sulfur ore. No chemicals are used in the process.

Overview of pond

Dredge

Dredge buckets

Floating WCP

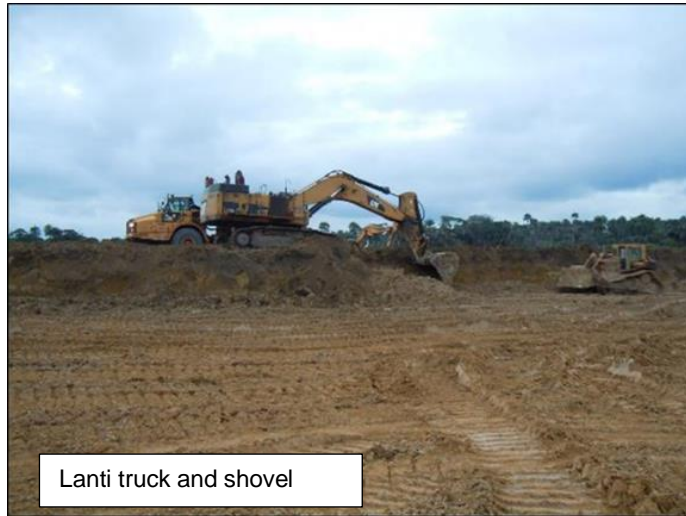
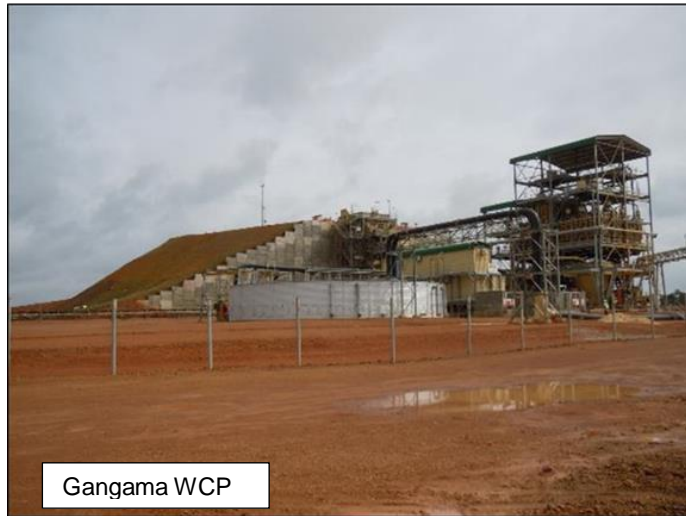
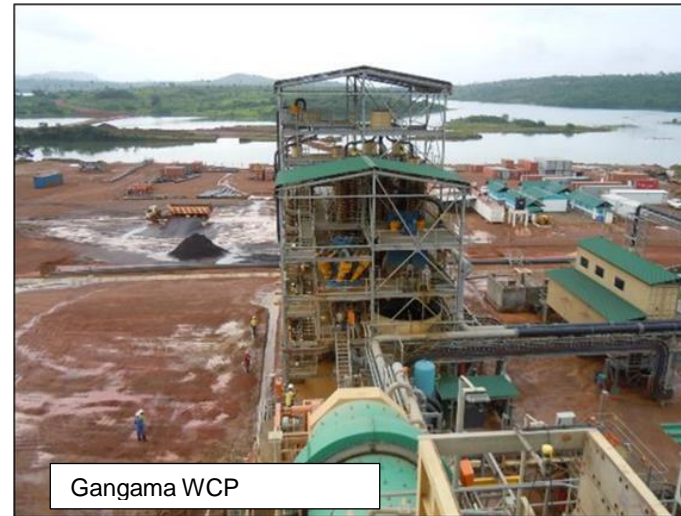
The sand tailings are classified into coarse and fine material and dealt with separately. The <1.6 mm material is produced from the land-based WCPs tails, while the coarse material comprises of screen oversize +1.6 mm – 200 mm. Fine material is pumped to a cyclone stacker, where it is stacked. The cyclones separate finer fractions from the coarse fractions to build sand beaches. The material is spread and moved with dozers. The recovery of process water is enhanced through the use of these cyclones. Oversize (+200 mm) material originating from the grizzly is discharged into an oversize bunker for removal by front end loader. Coarse material is transported by conveyors and dispersed by a spreader conveyor.

**Figure 2-6: Lanti (top row) and Gangama (bottom row) dry mining operations**

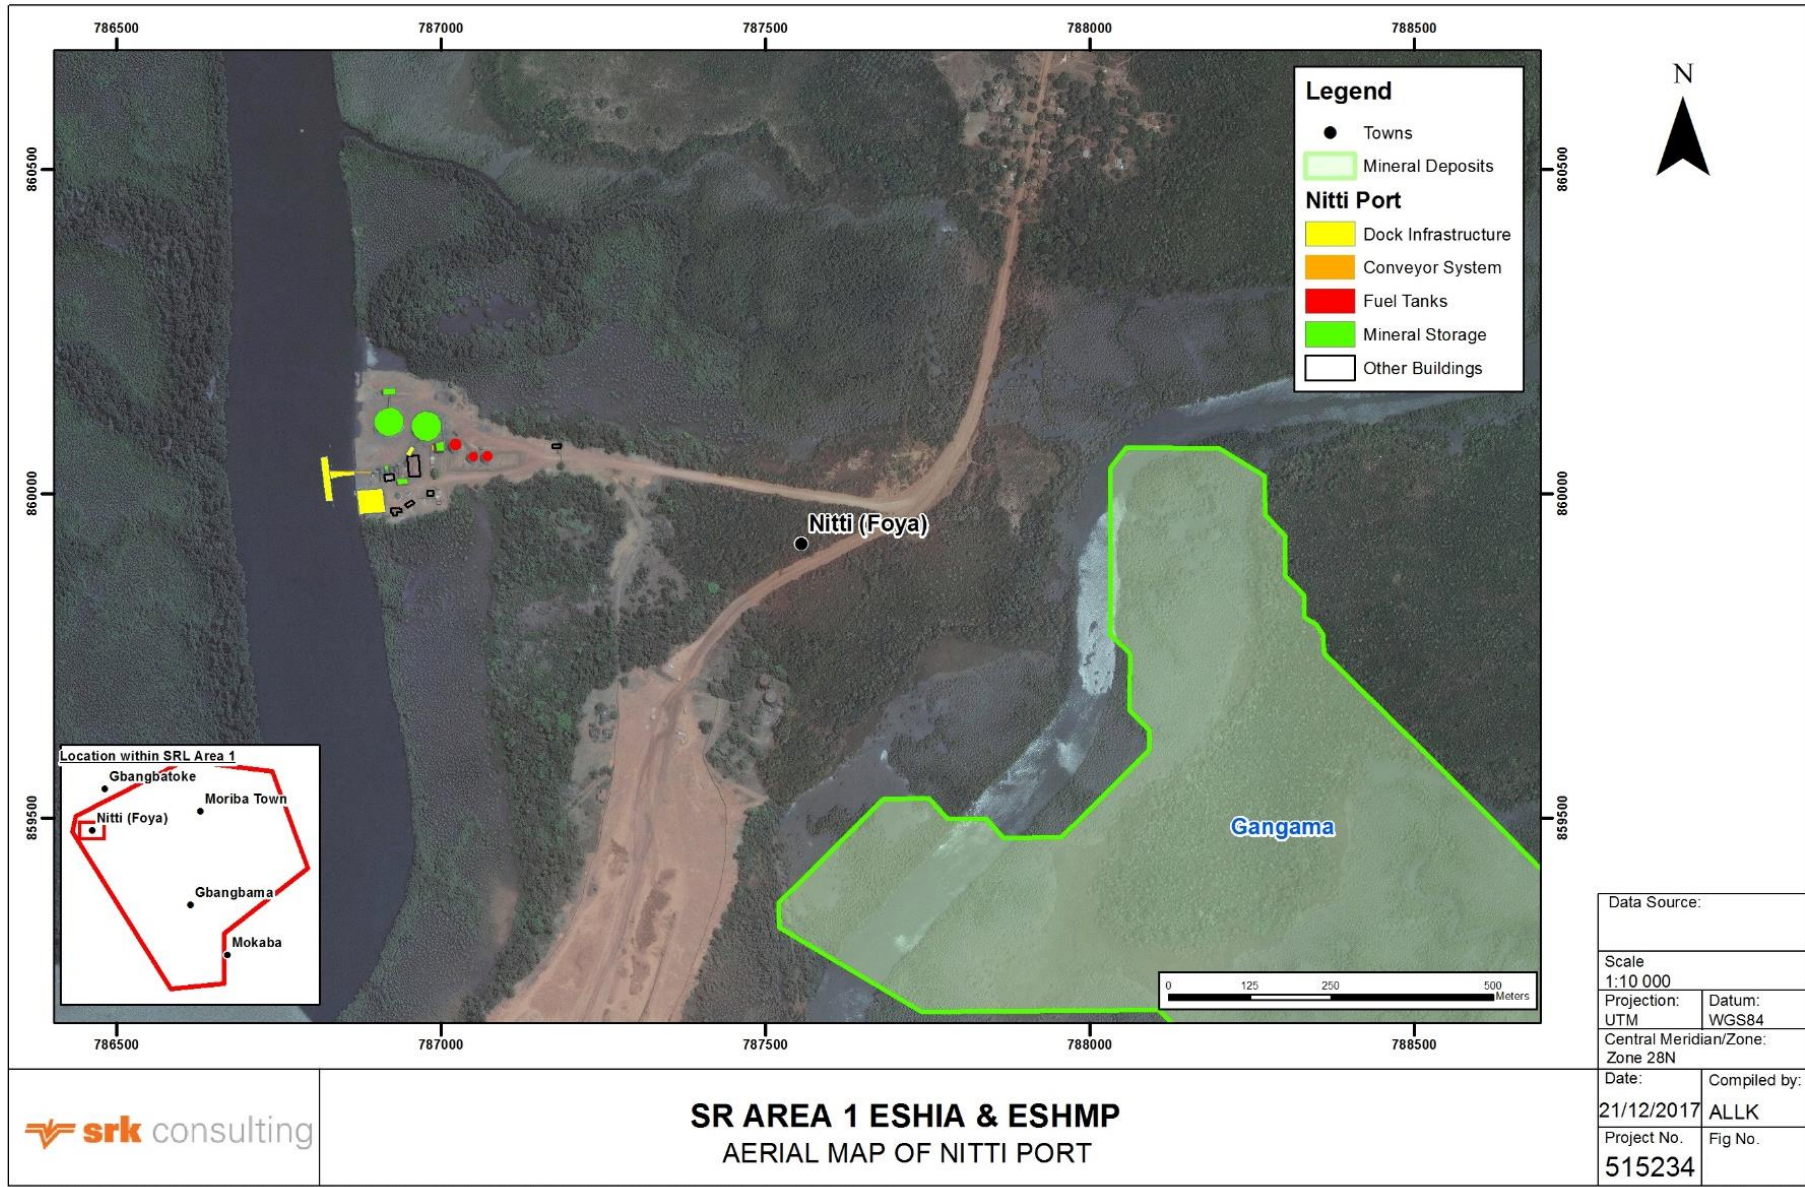
**Figure 2-9: Aerial overview of Nitti Port**

The port facilities are located at Nitti, approximately 4 km south of Gbangbatoke (Figure 2-9). The port facilities include an office building, other support (e.g. generator building) and storage buildings, product storage silos, product storage domes, loading facilities, Marine Fuel Oil storage tanks including 2,500 tonne IGR storage, barges and two push boats, with a third grounded near the jetty. There are four defunct rutile storage silos with capacity of 750 Mt each and two product storage domes each with a capacity of 12,000 metric tonnes for the storage of rutile and ilmenite respectively. The rutile and ilmenite concentrate product material is stored in the domes and silos.
